TO David Crawford, U S EPA Primary Contact  
THRU Russell B Krohn, <sup>RAN FOR</sup> Tetra Tech, Inc Regional Manager  
FROM <sup>DMD</sup> Mark Doolan, Tetra Tech, Inc Work Assignment Manager  
SUBJECT Elliott Shooting Park Cleanup - Status Report  
October 29, 1987 through November 12, 1987  
Work Assignment #194

Elliott Shooting Park  
Site Photographs

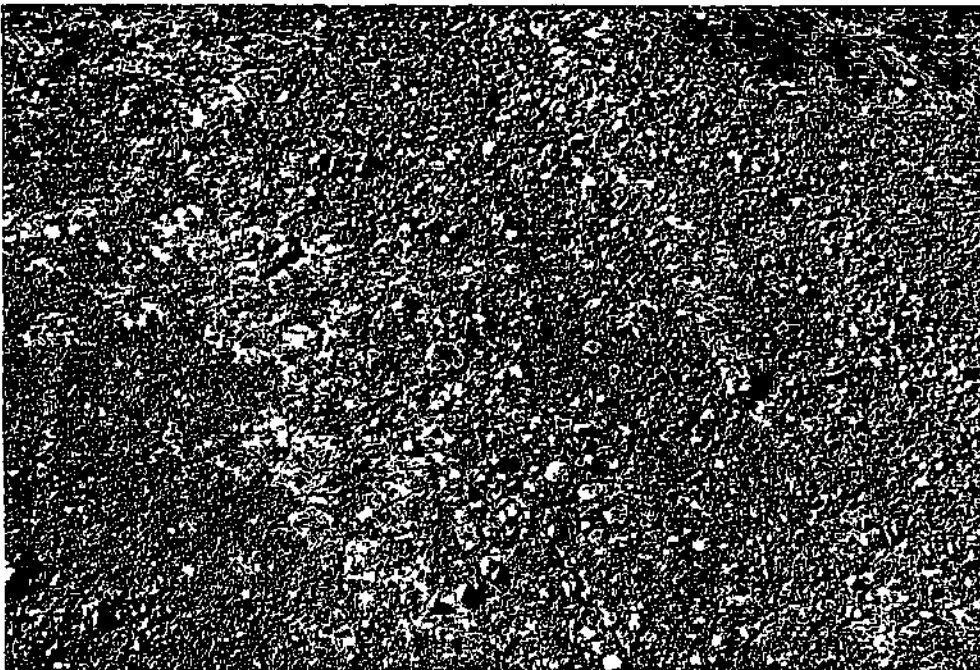
Exp Number 2  
Date 11/12/87  
Time 1341 hours  
Photographer M Doolan  
Witness None  
Camera Pentex K-1000  
Film Kodak ASA 200  
Direction N/A

Subject Ground surface in clay pigeon pit

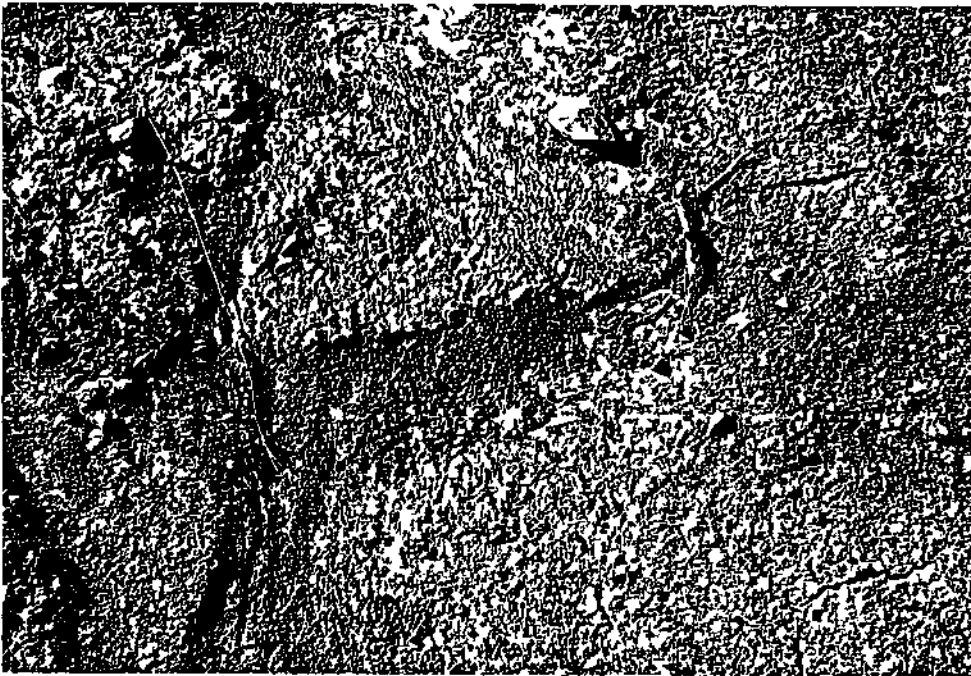
Exp Number 3  
Date 11/12/87  
Time 1345 hours  
Photographer M Doolan  
Witness None  
Camera Pentex K-1000  
Film Kodak ASA 200  
Direction N/A

Subject Ground surface in ditch north of ECA between building and parking lot  
with lead shot apparent

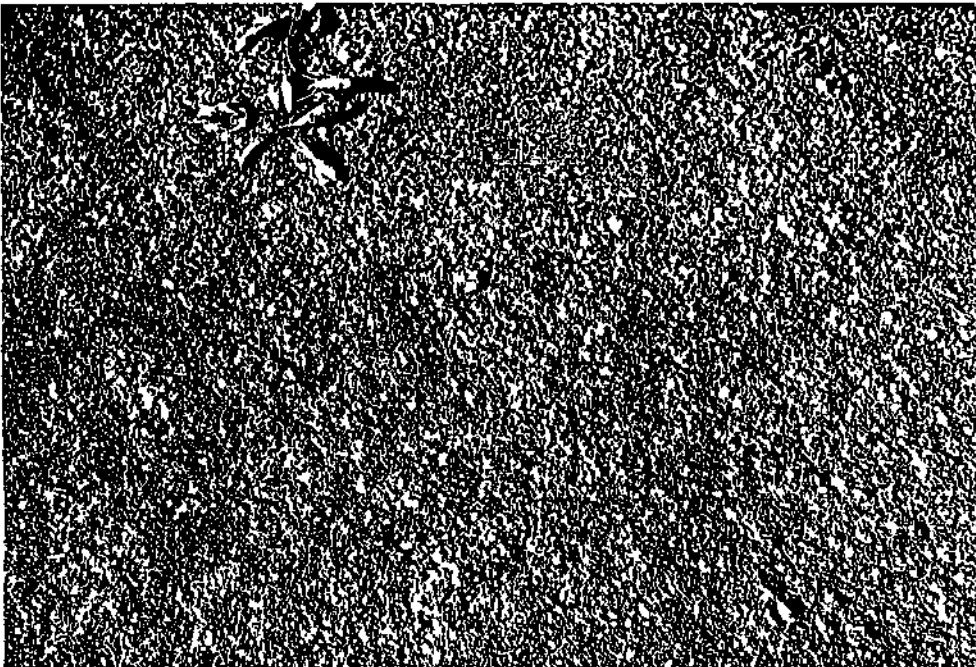
Exp Number 4  
Date 11/12/87  
Time 1346 hours  
Photographer M Doolan  
Witness None  
Camera Pentex K-1000  
Film Kodak ASA 200  
Direction N/A

Subject Ground surface in ditch north of ECA between building and parking lot  
with lead shot apparent

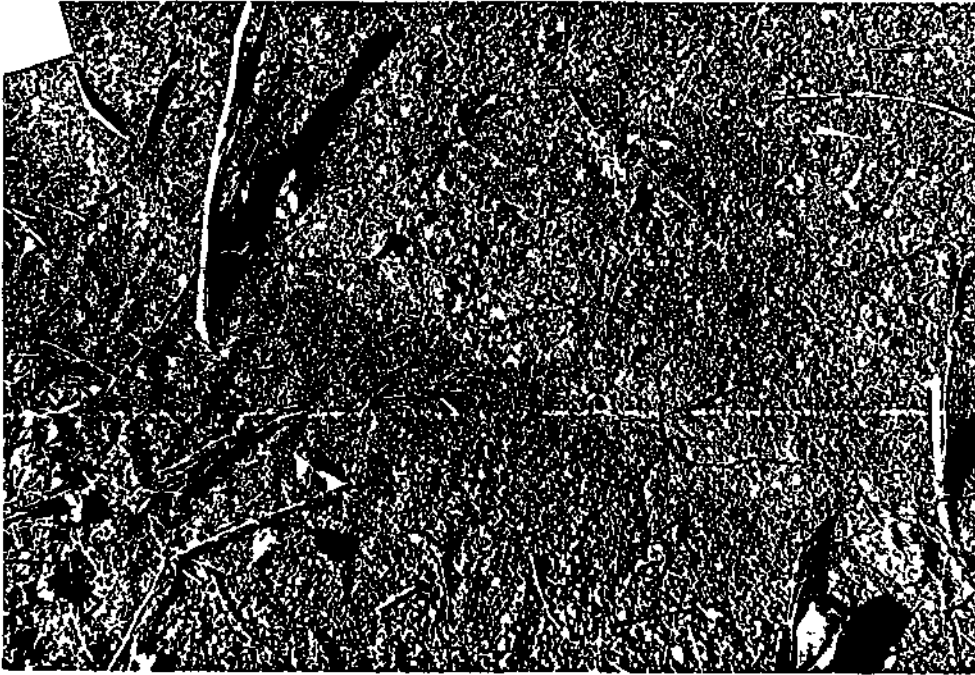
Exp Number 5  
Date 11/12/87  
Time 1350 hours  
Photographer M Doolan  
Witness None  
Camera Pentex K-1000  
Film Kodak ASA 200  
Direction N/A

Subject Ground surface north of ECA parking lot with lead shot apparent

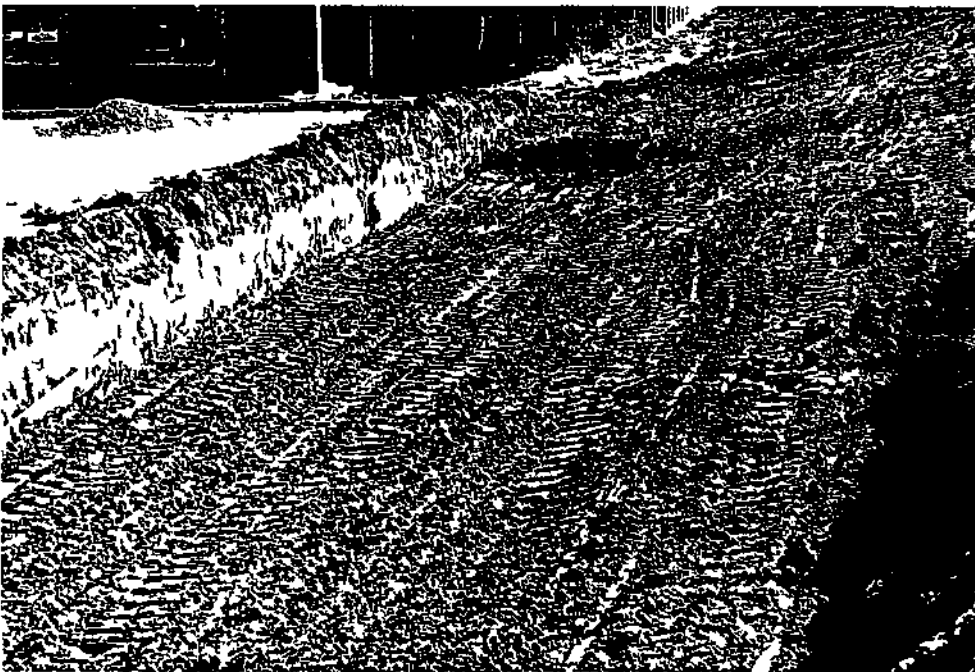
Exp Number 6  
Date 11/12/87  
Time 1353 hours  
Photographer M Doolan  
Witness None  
Camera Pentex K-1000  
Film Kodak ASA 200  
Direction S

Subject Area west of ECA parking lot prior to backfilling

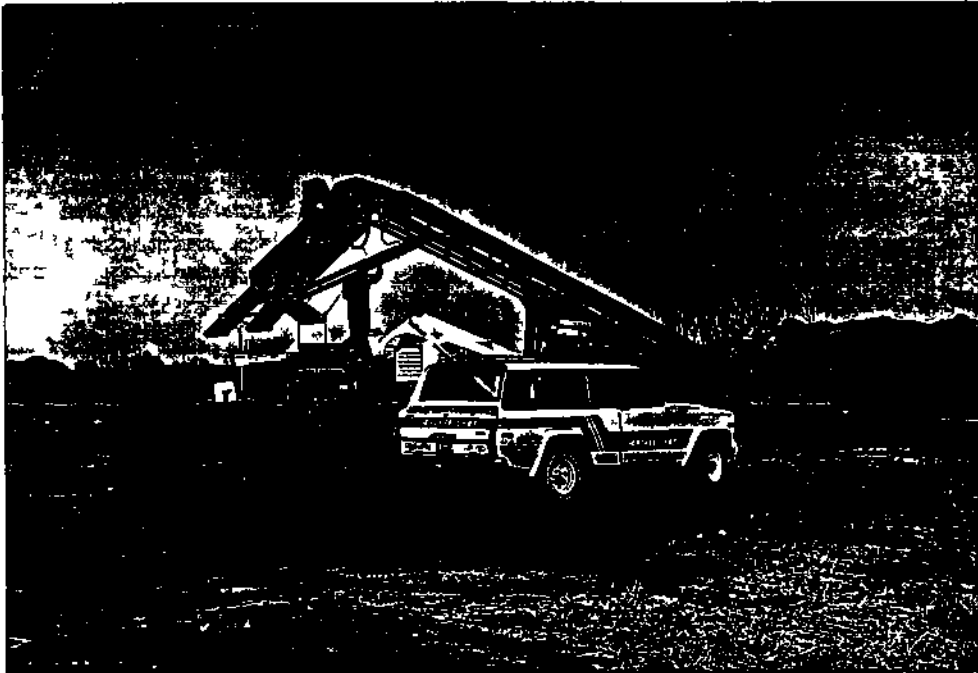
Exp Number 11  
Date 11/12/87  
Time 1410 hours  
Photographer M Doolan  
Witness None  
Camera Pentex K-1000  
Film Kodak ASA 200  
Direction NE

Subject Operator cleaning screen on shaker/sieve

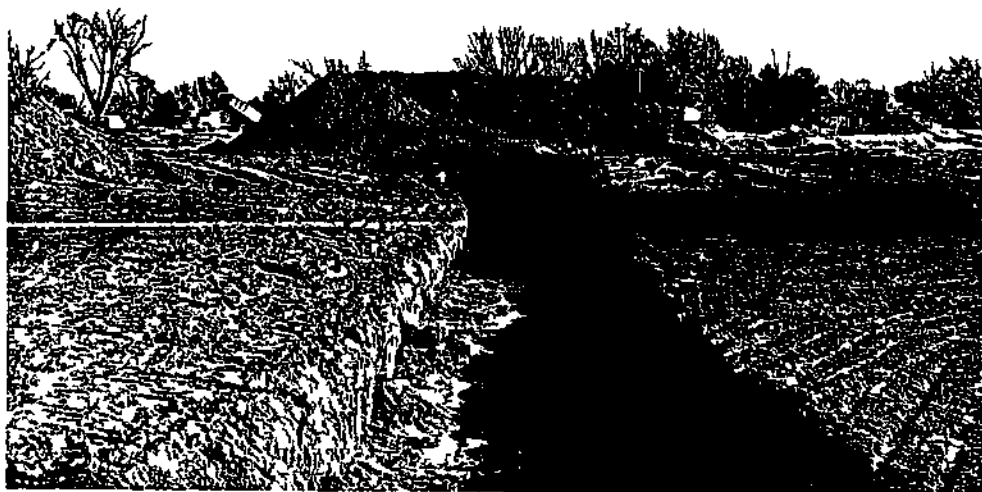
Exp Number 13  
Date 11/12/87  
Time 1415 hours  
Photographer M Doolan  
Witness None  
Camera Pentex K-1000  
Film Kodak ASA 200  
Direction E

Section J now contains substantial amounts of clay pigeon fragments and sediments that have washed in from areas to the east. A stockpile of soil containing visible lead shot is present approximately 15 feet east from the head of the trench. It is highly suspected that soil and shot from this pile has washed into the trench. Sections R and Y contained stockpiles of what appeared to be clean soil. The operators on site told Mr. Doolan that they did not know where the soil had originated, or the use for which it was intended. Mr. Doolan suspects that it is to be used for backfill at ECA and is concerned that lead from the Sections R and Y will be picked up while moving the soil to ECA.

Subject Stockpile of contaminated soil at head of trench in Section J

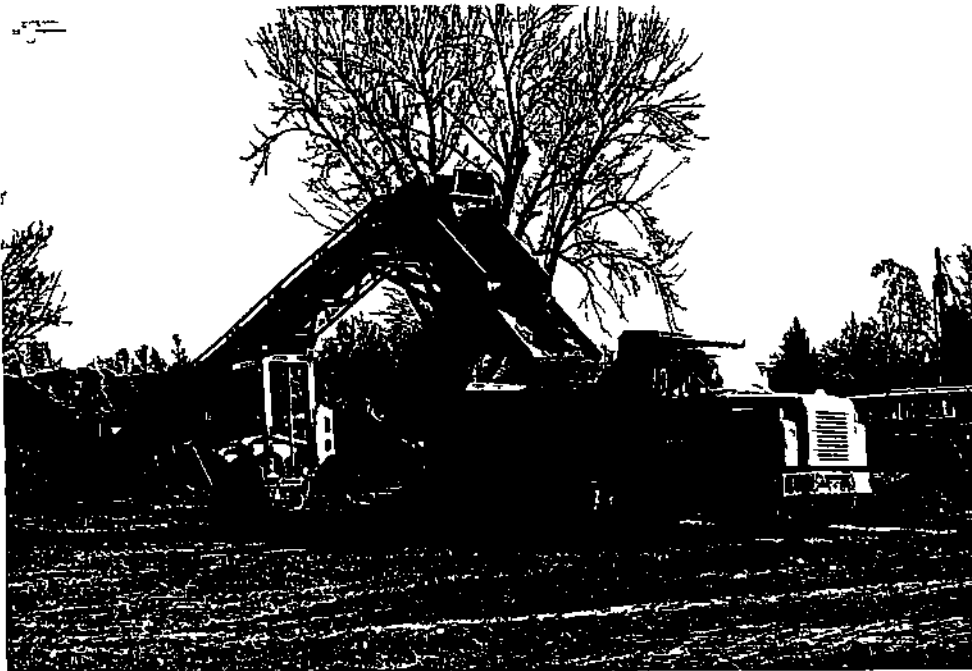
Exp Number 20  
Date 11/12/87  
Time 1425 hours  
Photographer M Doolan  
Witness None  
Camera Pentex K-1000  
Film Kodak ASA 200  
Direction SE

Subject Shaker operation in progress separating clay pigeon fragments from soil  
Clay pigeon fragments and soil falling into dump truck, soil falling to  
ground Some blowing dust apparent

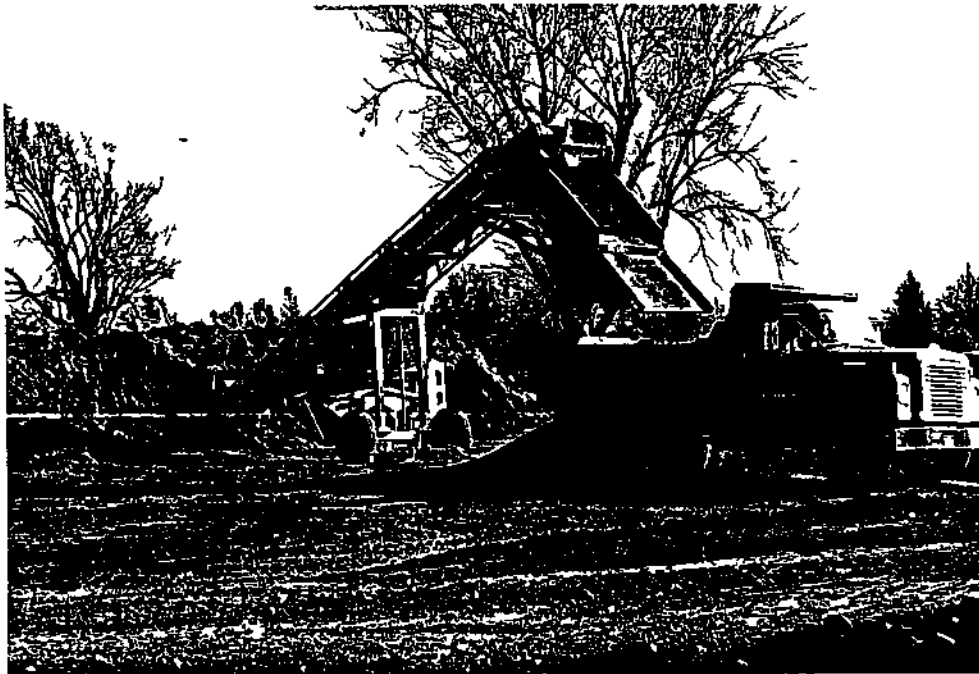
Exp Number 21  
Date 11/12/87  
Time 1426 hours  
Photographer M Doolan  
Witness None  
Camera Pentex K-1000  
Film Kodak ASA 200  
Direction E

Subject Shaker operation in progress separating clay pigeon fragments from soil  
Blowing dust apparent

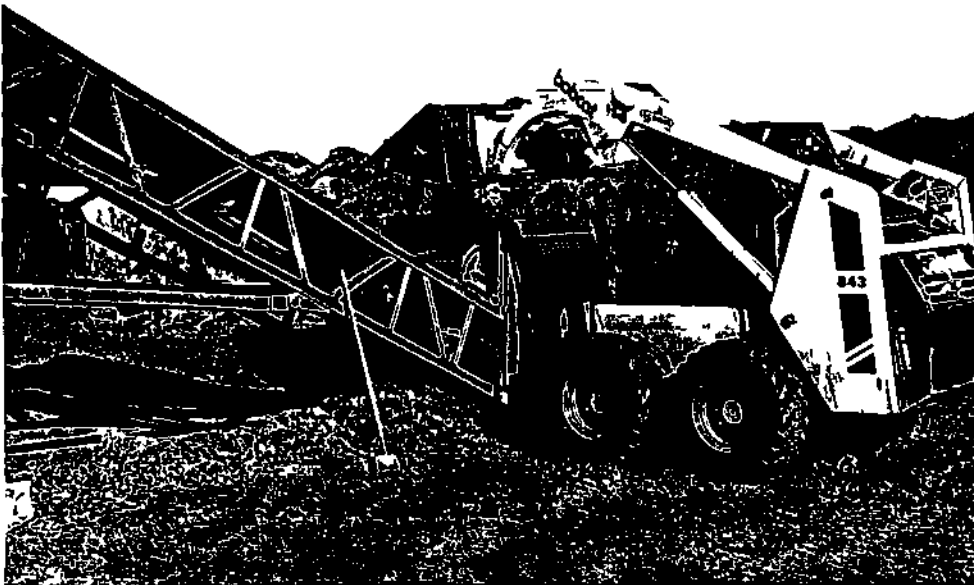
Exp Number 24  
Date 11/12/87  
Time 1431 hours  
Photographer M Doolan  
Witness None  
Camera Pentex K-1000  
Film Kodak ASA 200  
Direction E

Subject Operator loading shaker
